## Historian Corner

This issue is part 2 of the profile of the third planned lunar landing Apollo mission: Apollo 13. A minor clarification is in order- the wording was incorrect in the first paragraph of the Program Profile article in the previous MARS STAR. Apollo 13 was obviously not the third Apollo mission, but was the third planned lunar landing and the seventh manned Apollo mission overall.

Part 2 of the Apollo 13 Profile focuses on the aftermath and the failure investigation.

### Oxygen Tank No. 2 Build & Assembly History

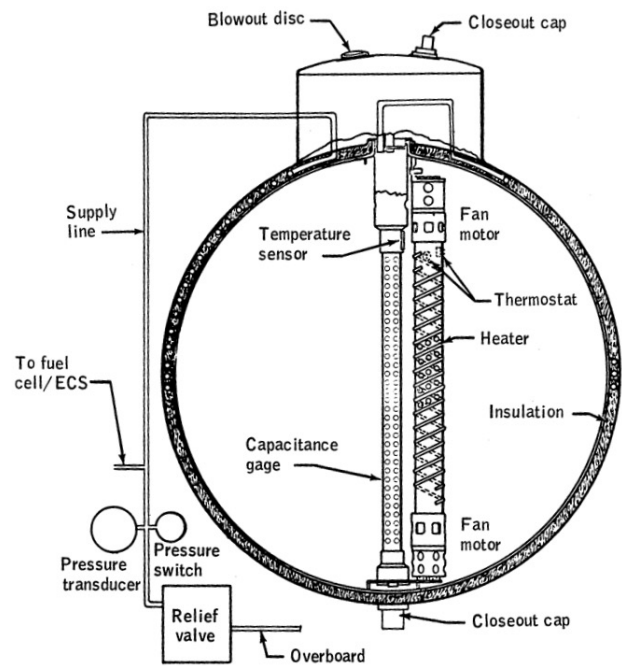
On February 26, 1966, North American Aviation company and primary contractor for the Apollo Command Module (CM)/Service Module (SM) systems (later becoming North American Rockwell) awarded a subcontract to Beech Aircraft Corporation (located in north Boulder, Colorado) to build the Block II cryogenic gas storage subsystem for the service module. The simplified drawing below shows the design of the oxygen tank, with an inner and outer shell arranged to provide a vacuum space to reduce heat leak, and a dome enclosing the path into the tank for transmission of fluids and electrical power and signals. Insulation fills the spaces between the shells and in the dome. Two tubular assemblies are mounted in the tank: the heater tube contains two thermostatically protected heater coils and two small fans (1800 rpm) to stir the tank contents and the quantity probe has a capacitance gage to measure electrically the quantity of fluid in the tank. The inner cylinder of this second probe serves as a fill and drain tube and as one plate of the capacitance gage. A temperature sensor is mounted on the outside of the quantity probe near the head. The supply line from the tank leads from the head of the quantity probe to the dome, exiting through the dome to supply oxygen to the fuel cells in the SM and the Environmental Control System in the CM; the line also connects to a relief valve. Under normal conditions pressure in the tank is measured by a gage in the supply line and a switch near the gage turns on heaters in the tank if the pressure drops below a specified value.

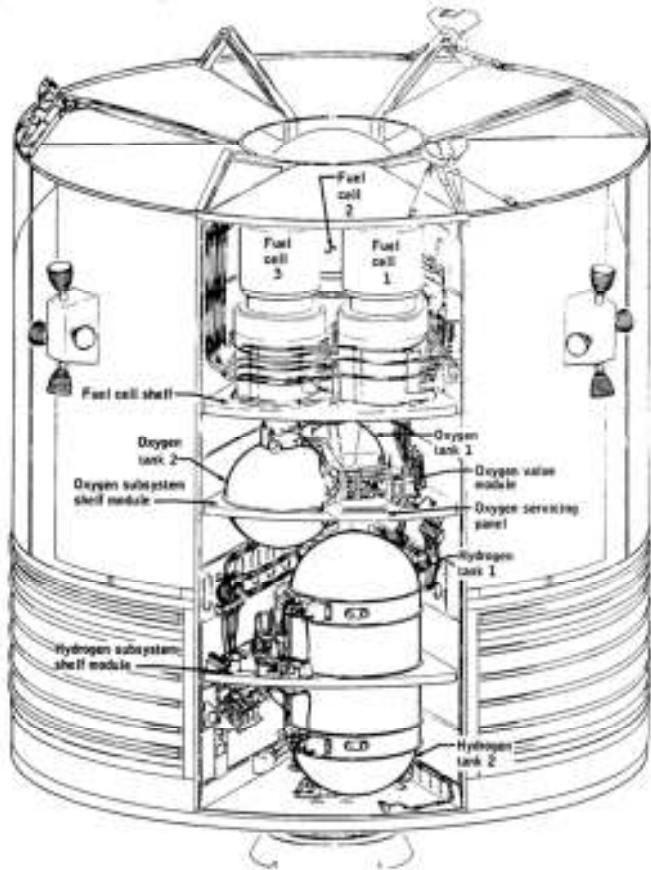
The oxygen tank is designed for a capacity of 320 pounds of super-critical oxygen (oxygen maintained at temperatures and pressures that ensure it is a homogenous, single-phase fluid) at pressures from 865 to 935 psia, operating at temperatures from -340 degrees F to +80 degrees F. Burst pressures are at 2200 psi at -150 degrees F.

S/N 10024XTA0008 Oxygen Tank Number 2 (Apollo 13 tank) was manufactured in 1966 and was the eighth block II tank built; 28 block I tanks had previously been built by Beech. The assembly process results in a substantial amount of wire movement inside tank, where possible wire insulation damage can occur and not be detected before the tank is capped off and welded closed. Some tank rework was required due to welding flaws and a faulty fan motor. Acceptance testing of the tank included dielectric, insulation, and functional tests of heaters, fans, and vac-ion pumps. The tank itself was leak tested at 500 psi and proof tested at 1335 psi with helium. After the proof test, the tank was filled with liquid oxygen and pressurized to a proof pressure of 1335 psi by use of the tank heaters powered by 65 V (AC). Heat-leak tests were run over 25-30 hours over a range of conditions and outflow rates. The tank was then emptied by forcing the LOX out through the fill line. The rate of heat leak into the tank was higher than permitted by specifications and was accepted with a waiver of this condition (this apparently did not factor
