MARTIN MARIETTA

### NUMBER 12/1976

## Viking 2 lands safely, begins experiments

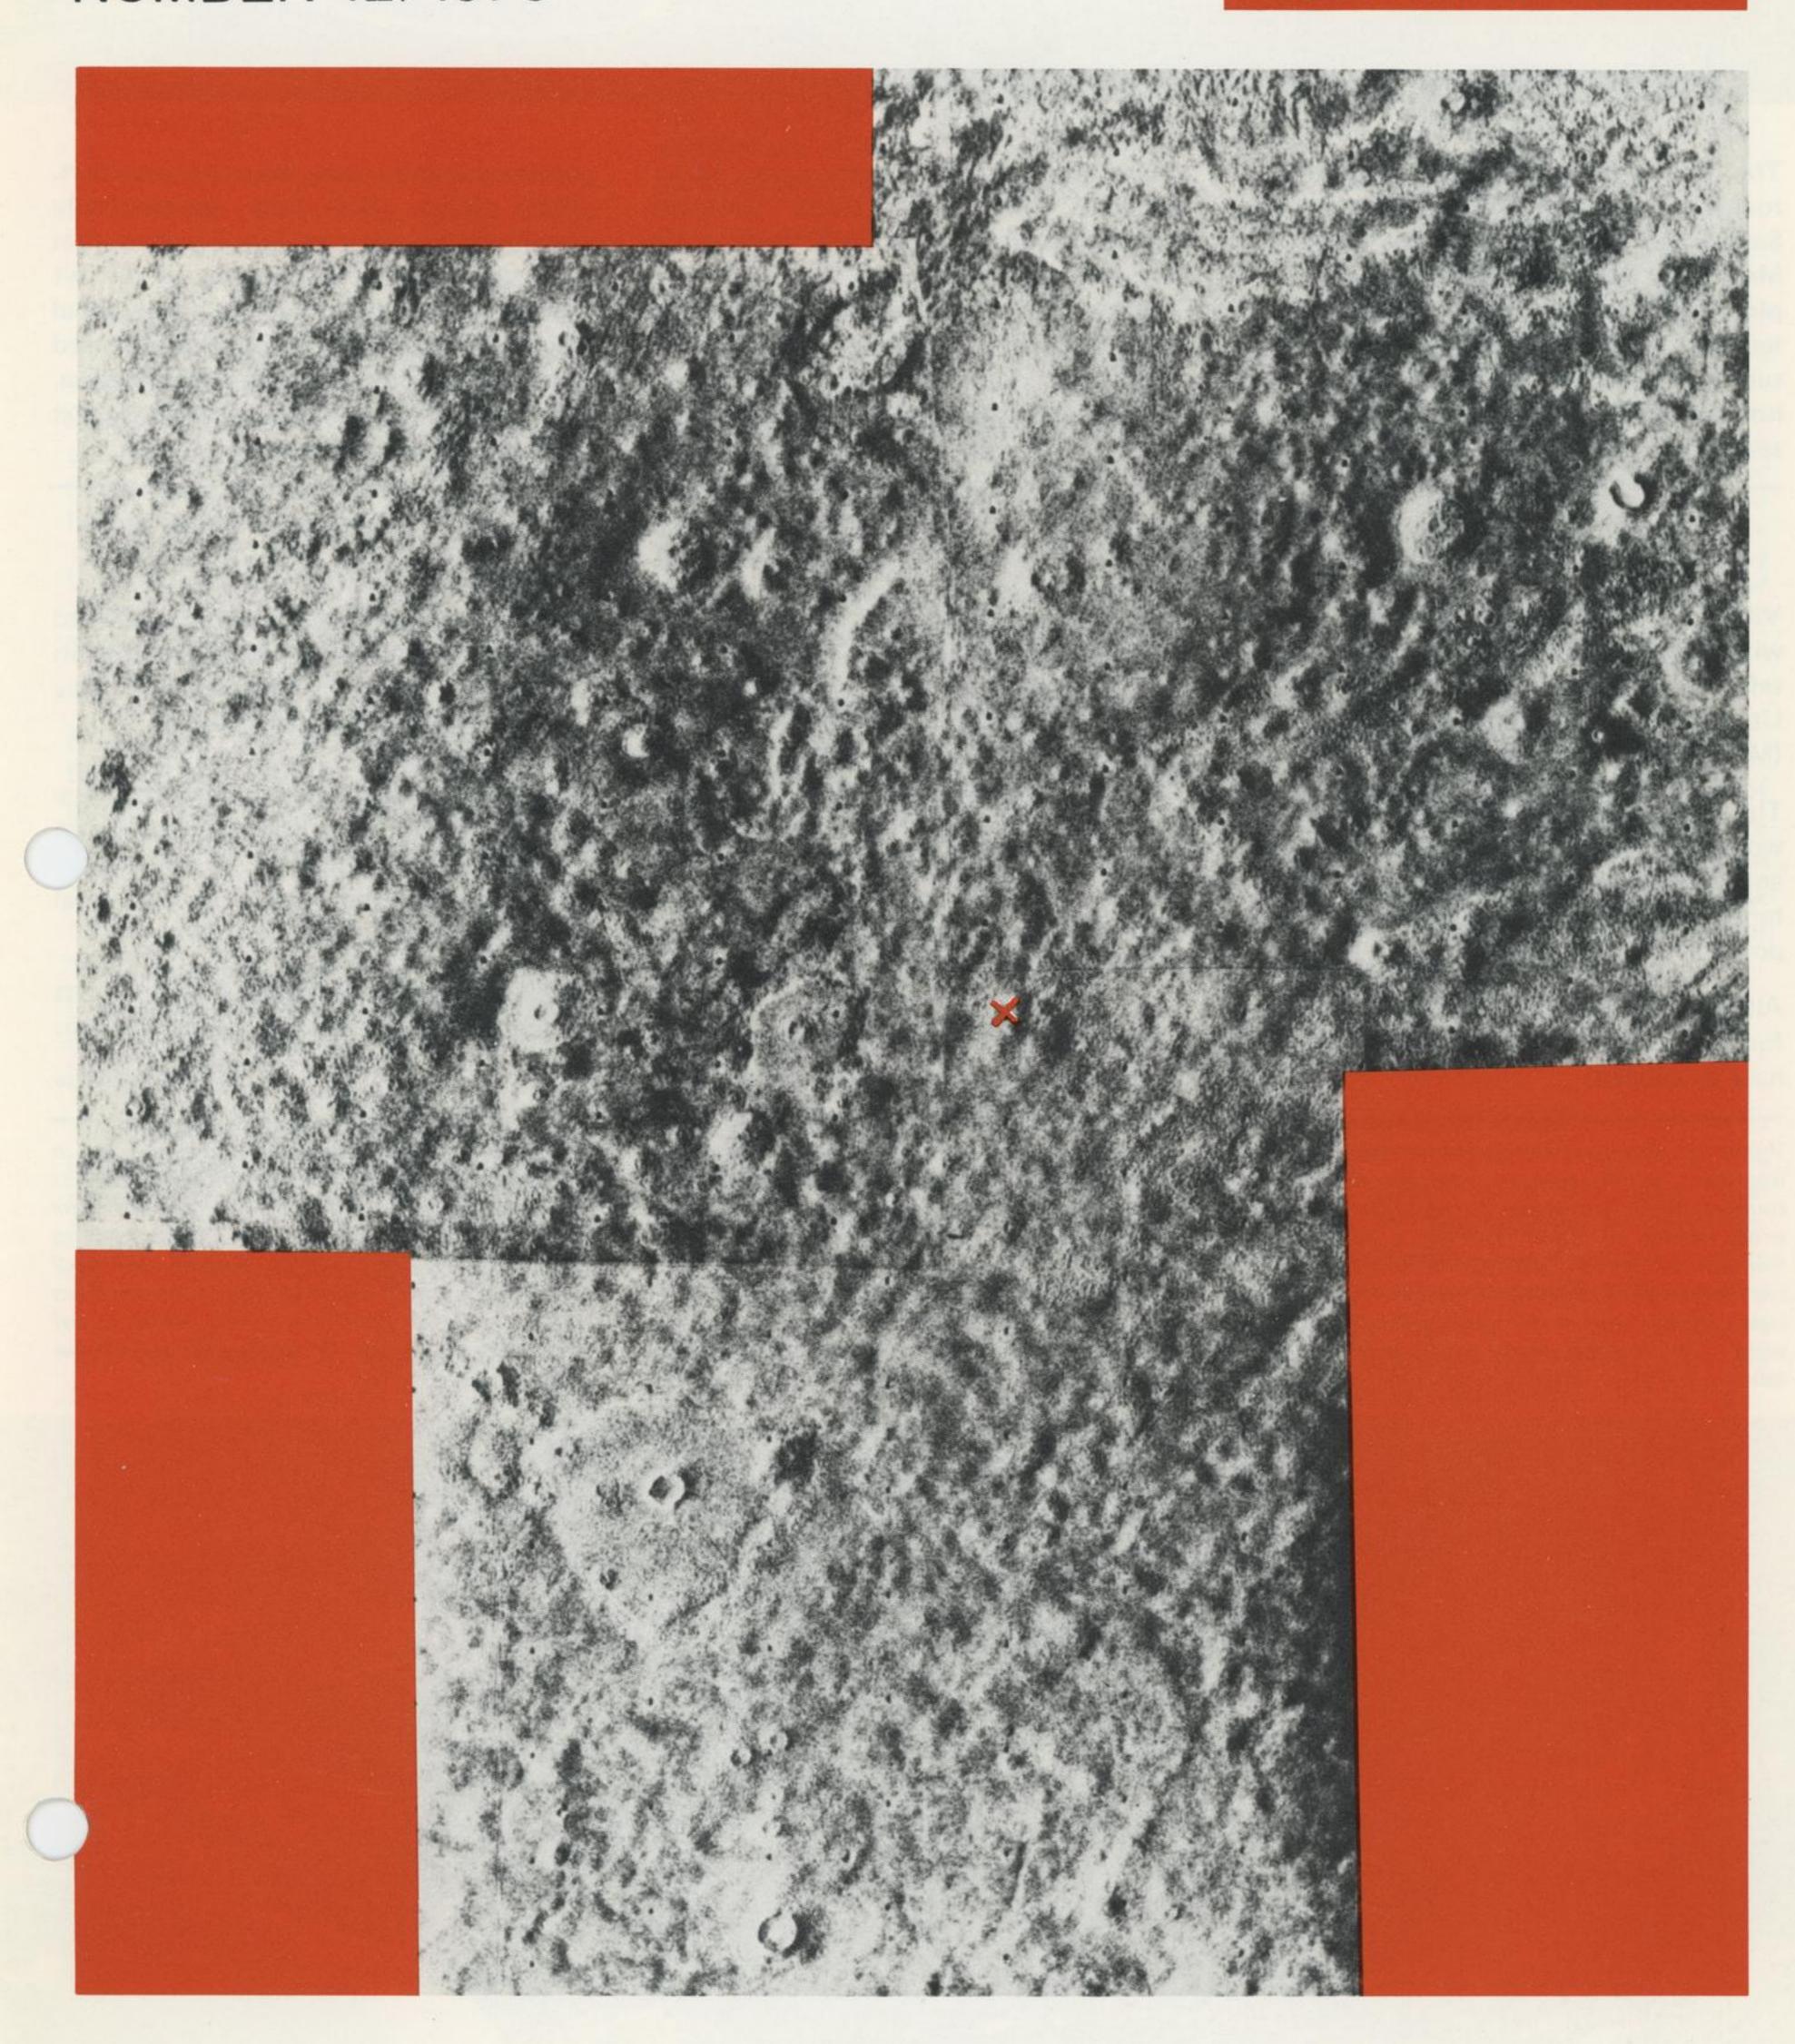
"X" marks the spot selected as the landing site for Viking 2, located in the eastern end of Utopia Planitia on Mars: 48° North and 226° West. The lander actually set down at 47.97° North and 225.67° West. The three frames were taken by the Viking 2 Orbiter August 16 from a distance of about 3360 kilometers (2100 miles). The frame dimensions are about 90 x 100 kilometers (56 x 62 miles).

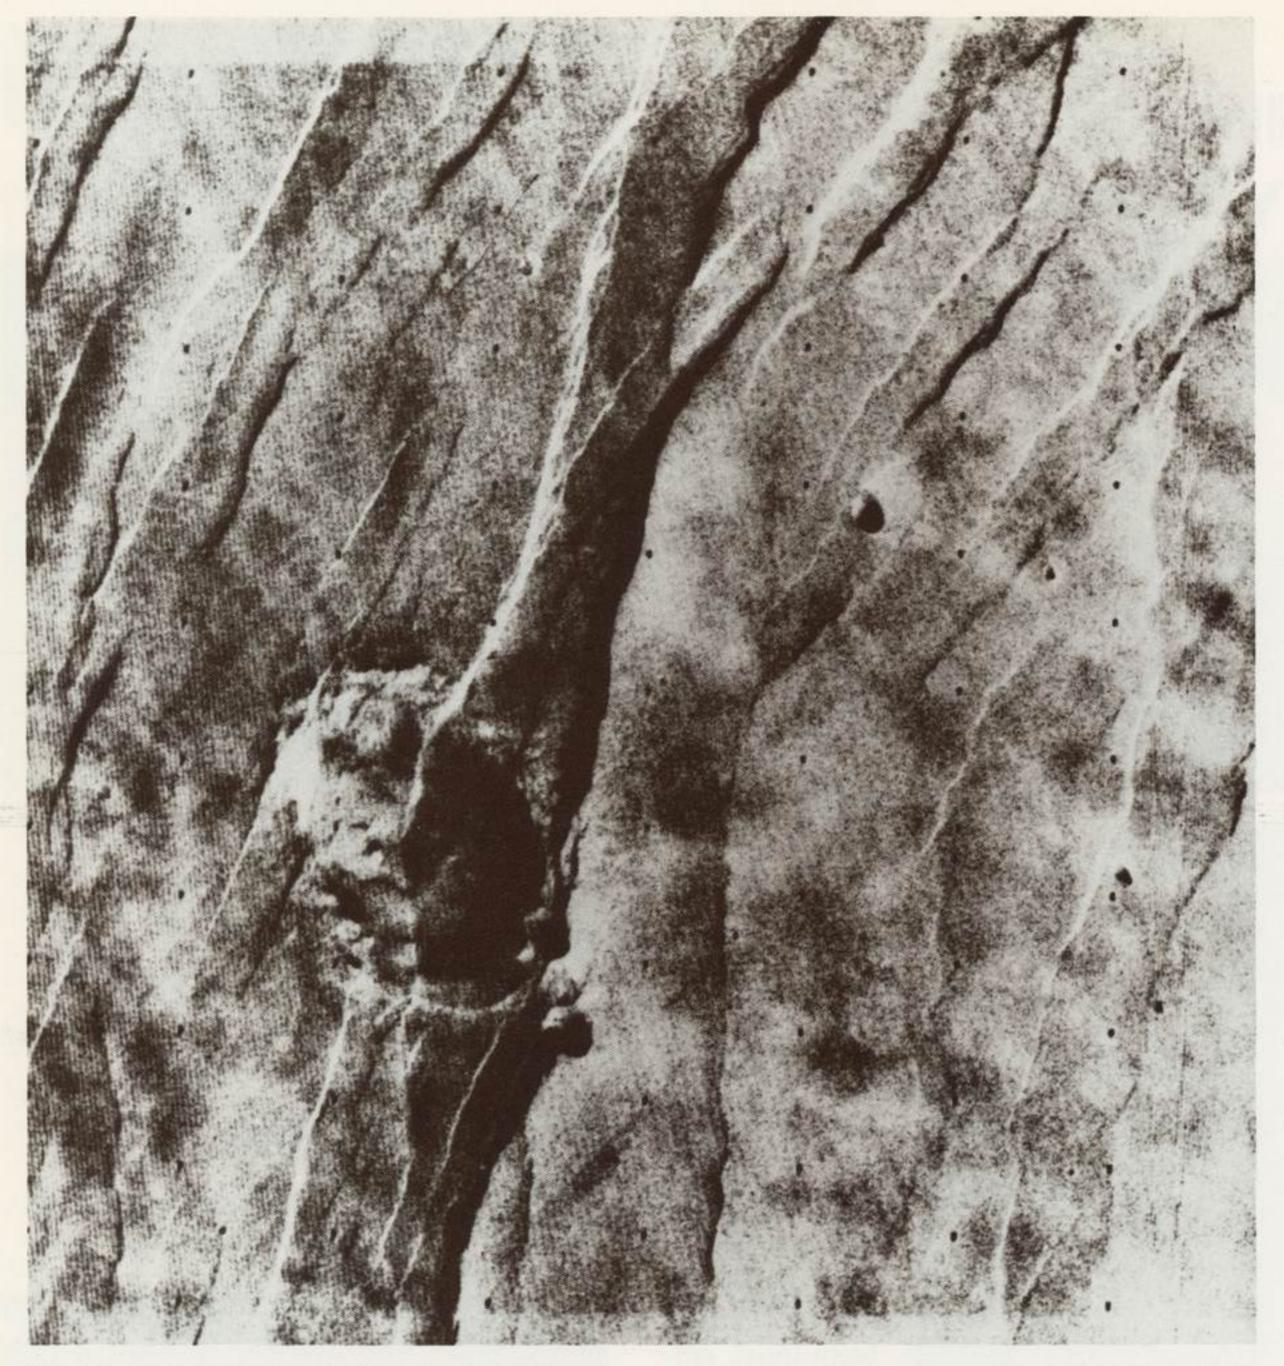
Viking 2 began its search for a landing site on Mars in mid August with photos by the Orbiter TV cameras of an area called Alba Patera, or "White Saucer." Located at about 110° W. Long., 44° N. Lat., the region is a low volcanic plateau. Faults, or breaks in the crust, bound the plateau and slice through the impact crater seen in this picture. Taken during the Martian

morning with the sun high and atmospheric haze still present, these first pictures show a surface which appears smooth. Small details will be seen in photos to be taken in the afternoon, with the sun low on the horizon. This picture was taken from a range of 220 kilometers (1370 miles) and shows an area of about 6500 square kilometers (2500 square miles).

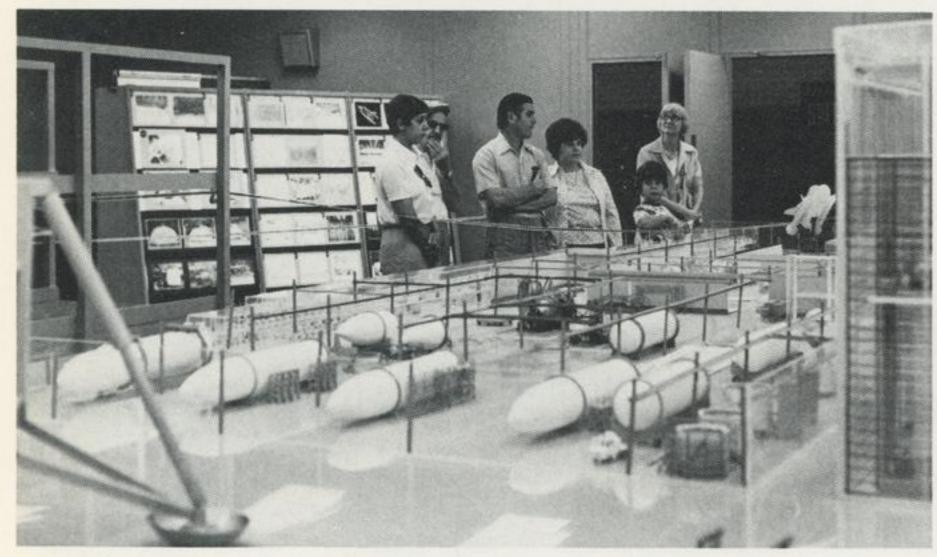
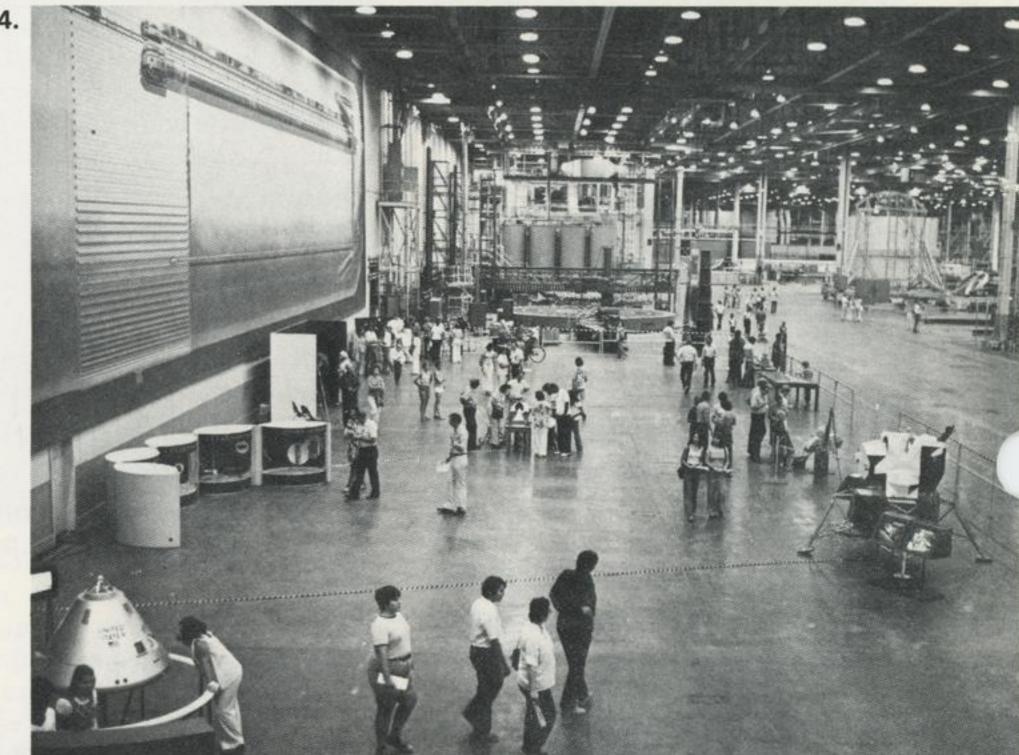
1-Model room shows layout of facility; 2-Subassembley area in which domes for external tanks are fabricated; 3-Viking lander scale model was on display; 4-Overview of display area with oil painting of full-size external tank; 5 - Completed barrel section of liquid hydrogen tank prepared for transport to xray; 6-Forward and aft ogive fixtures; 7-Orbiter cargo bay display had European Space Agency lab as pay load; 8-Horizontal hydrogen tank barrel tool.
